APPENDIX A: NORTH 27TH STREET CPTED REVIEW

In July of 2017, a block-by-block CPTED walk, between West State Street and West St. Paul Avenue, was conducted as part of the North 27th Street Corridor Strategy. The following summarizes some initial CPTED observations and recommendations for the North 27th Street commercial corridor.

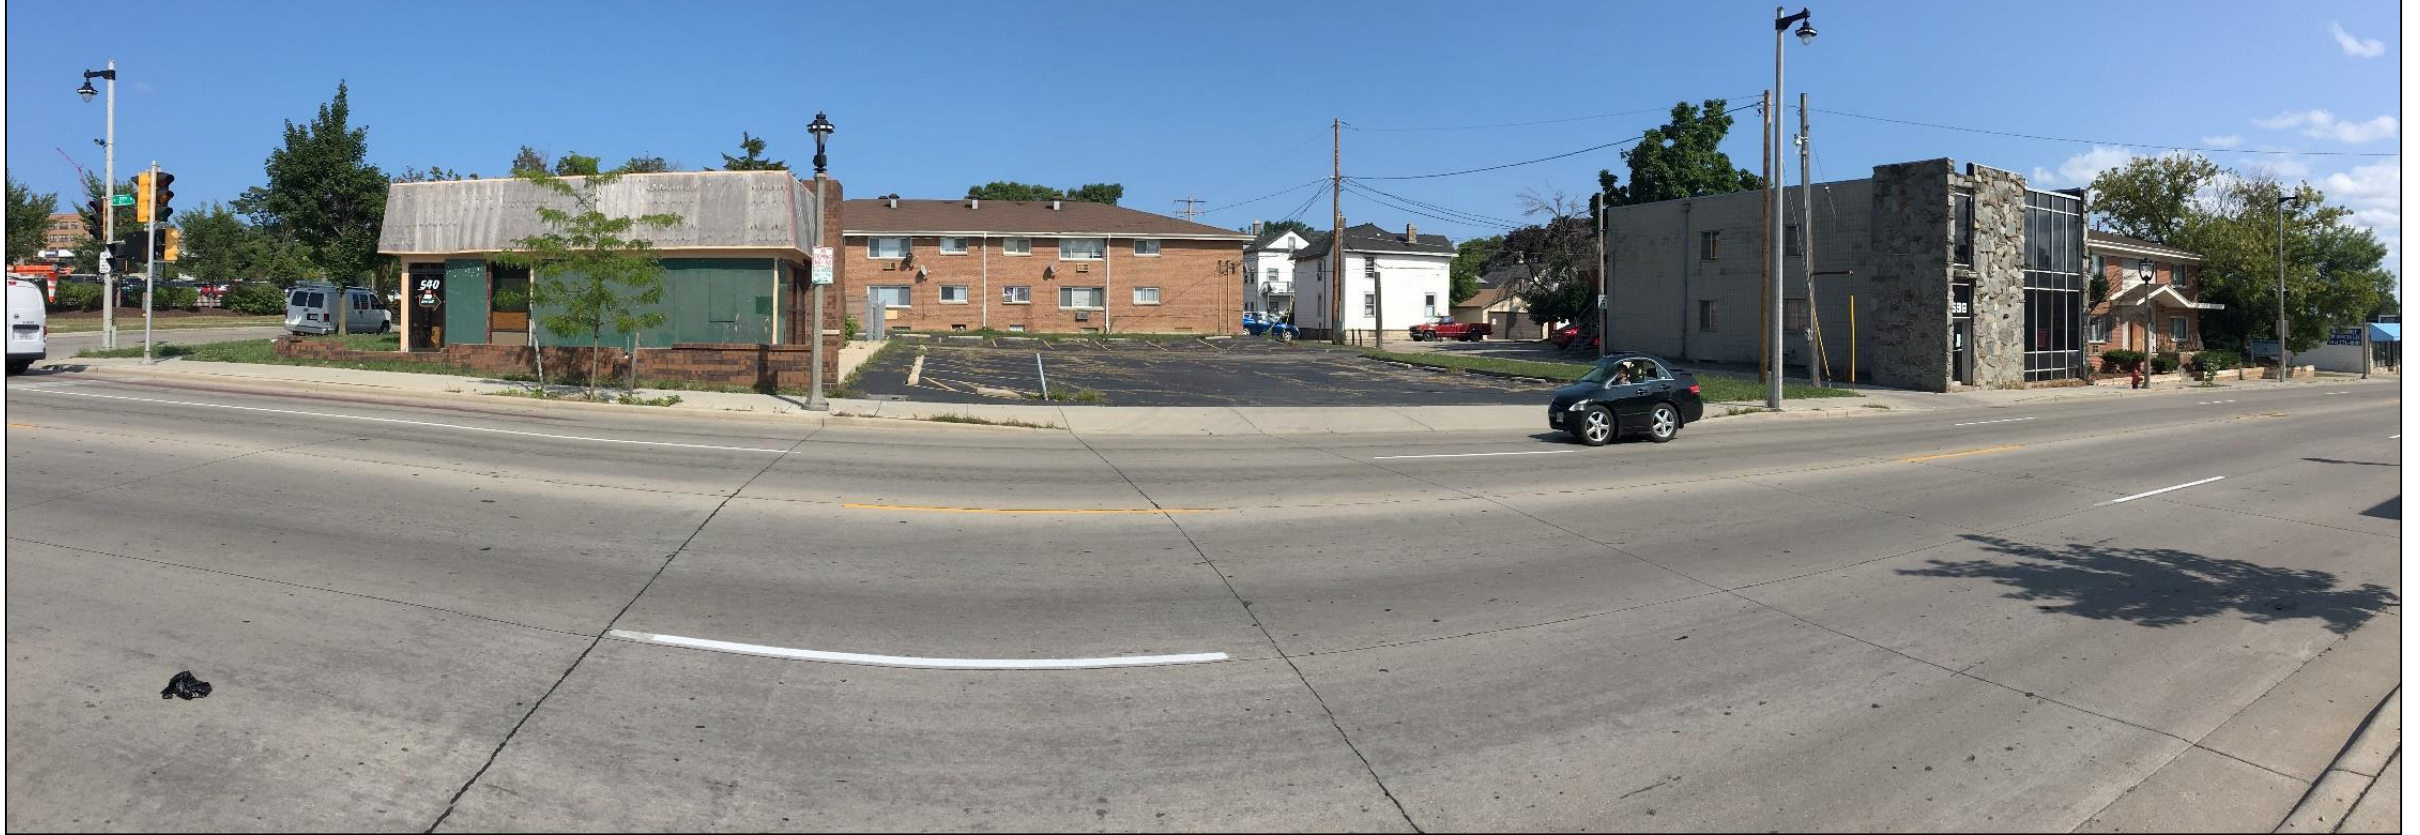
500 Block

- Future re-use or new development should ensure façade contains ample transparent glazing and the parking lot is landscaped and properly lighted.

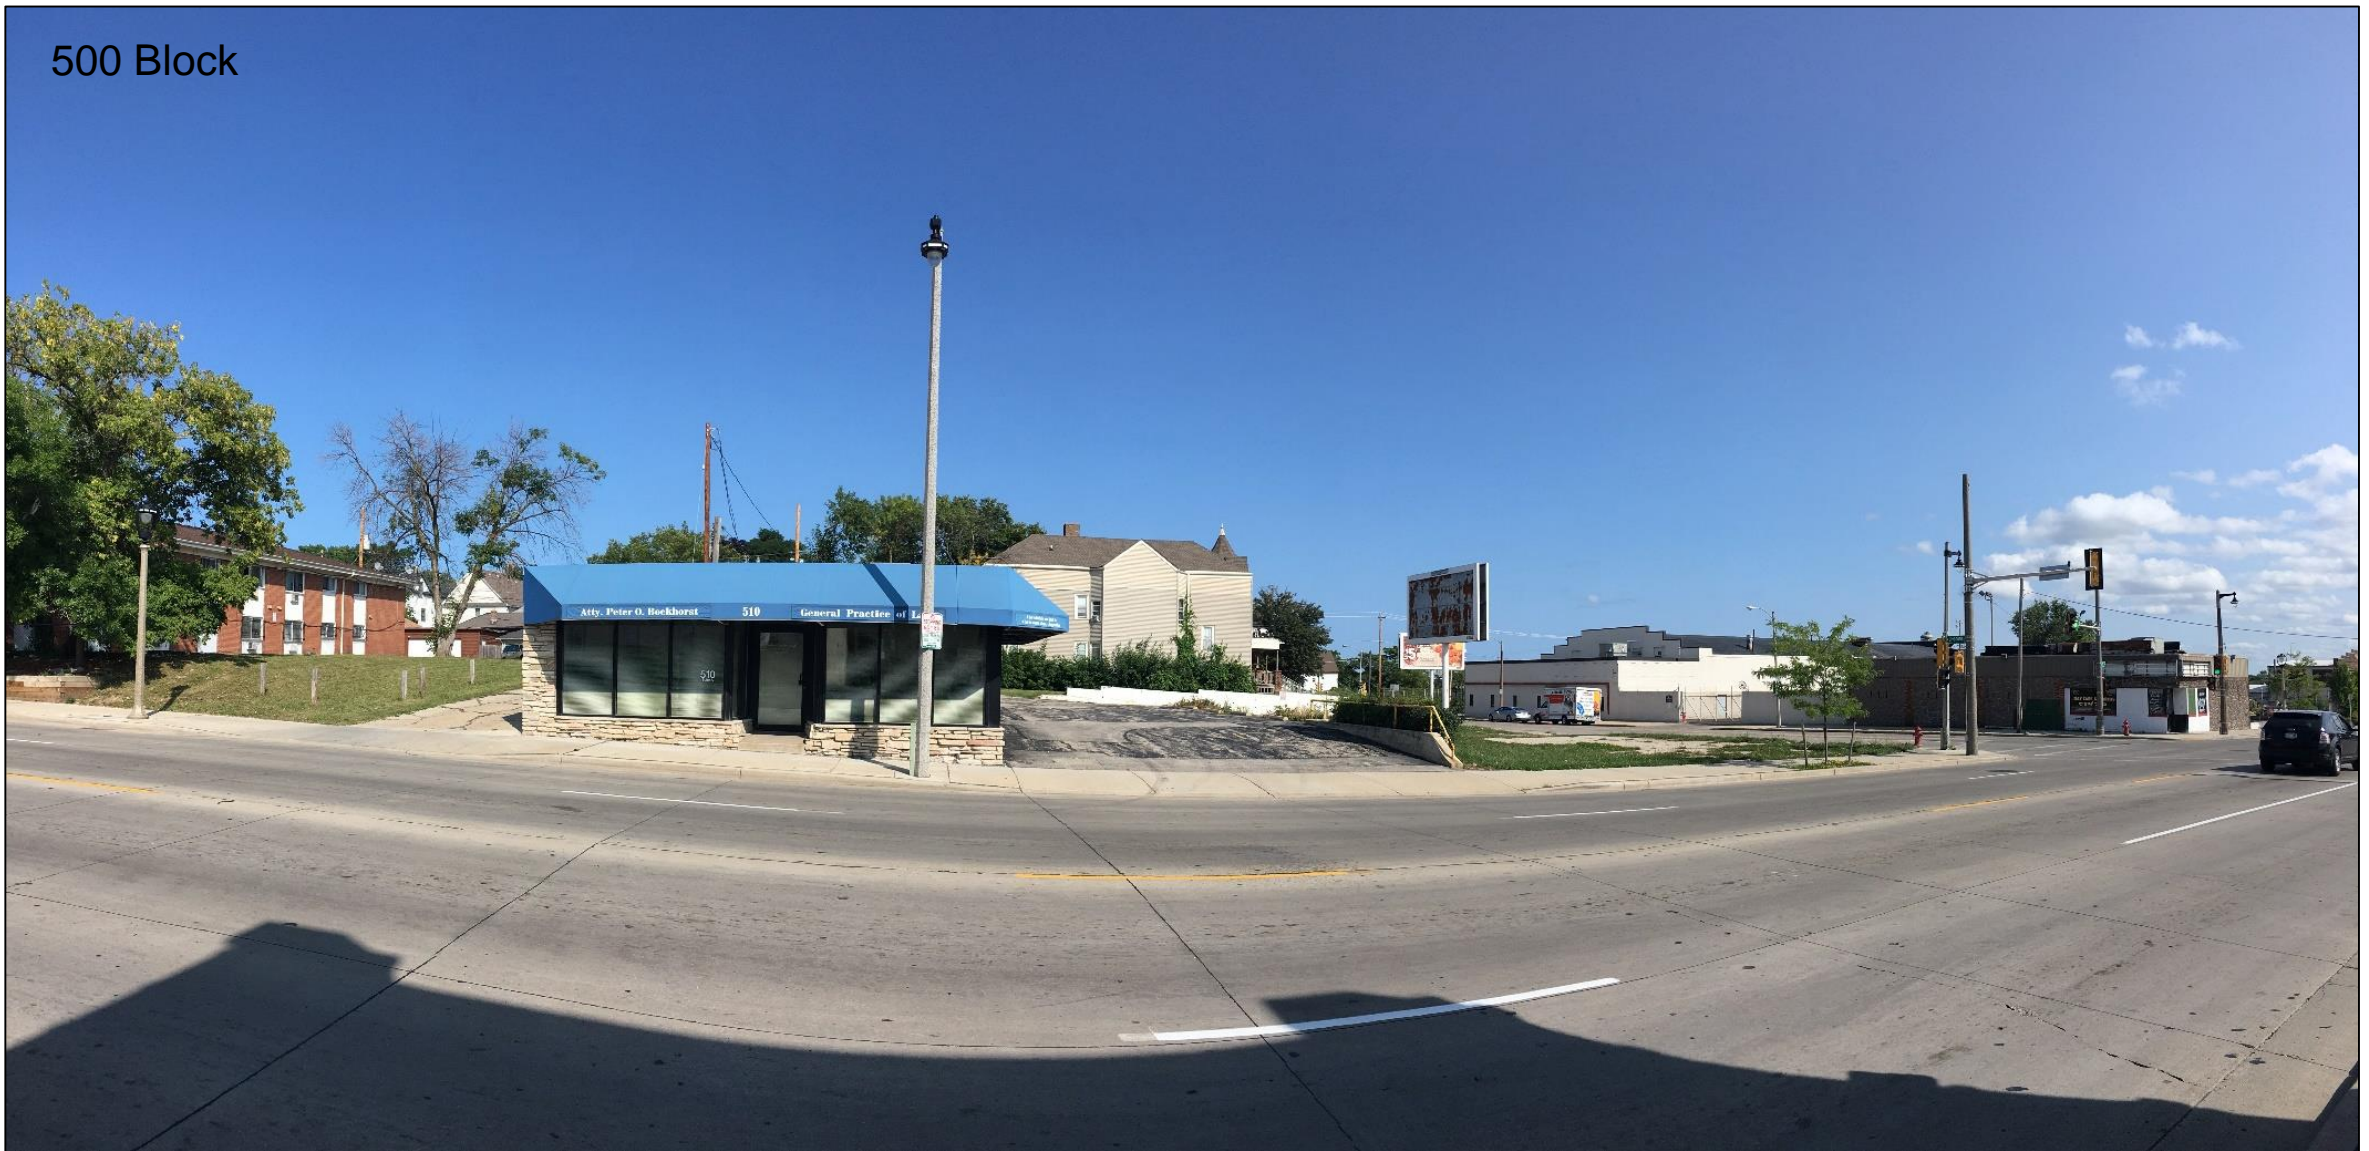
500 Block

- Improve vacant corner lot at visible intersection with landscaping or, at a minimum, a fully grassed and maintained lot.

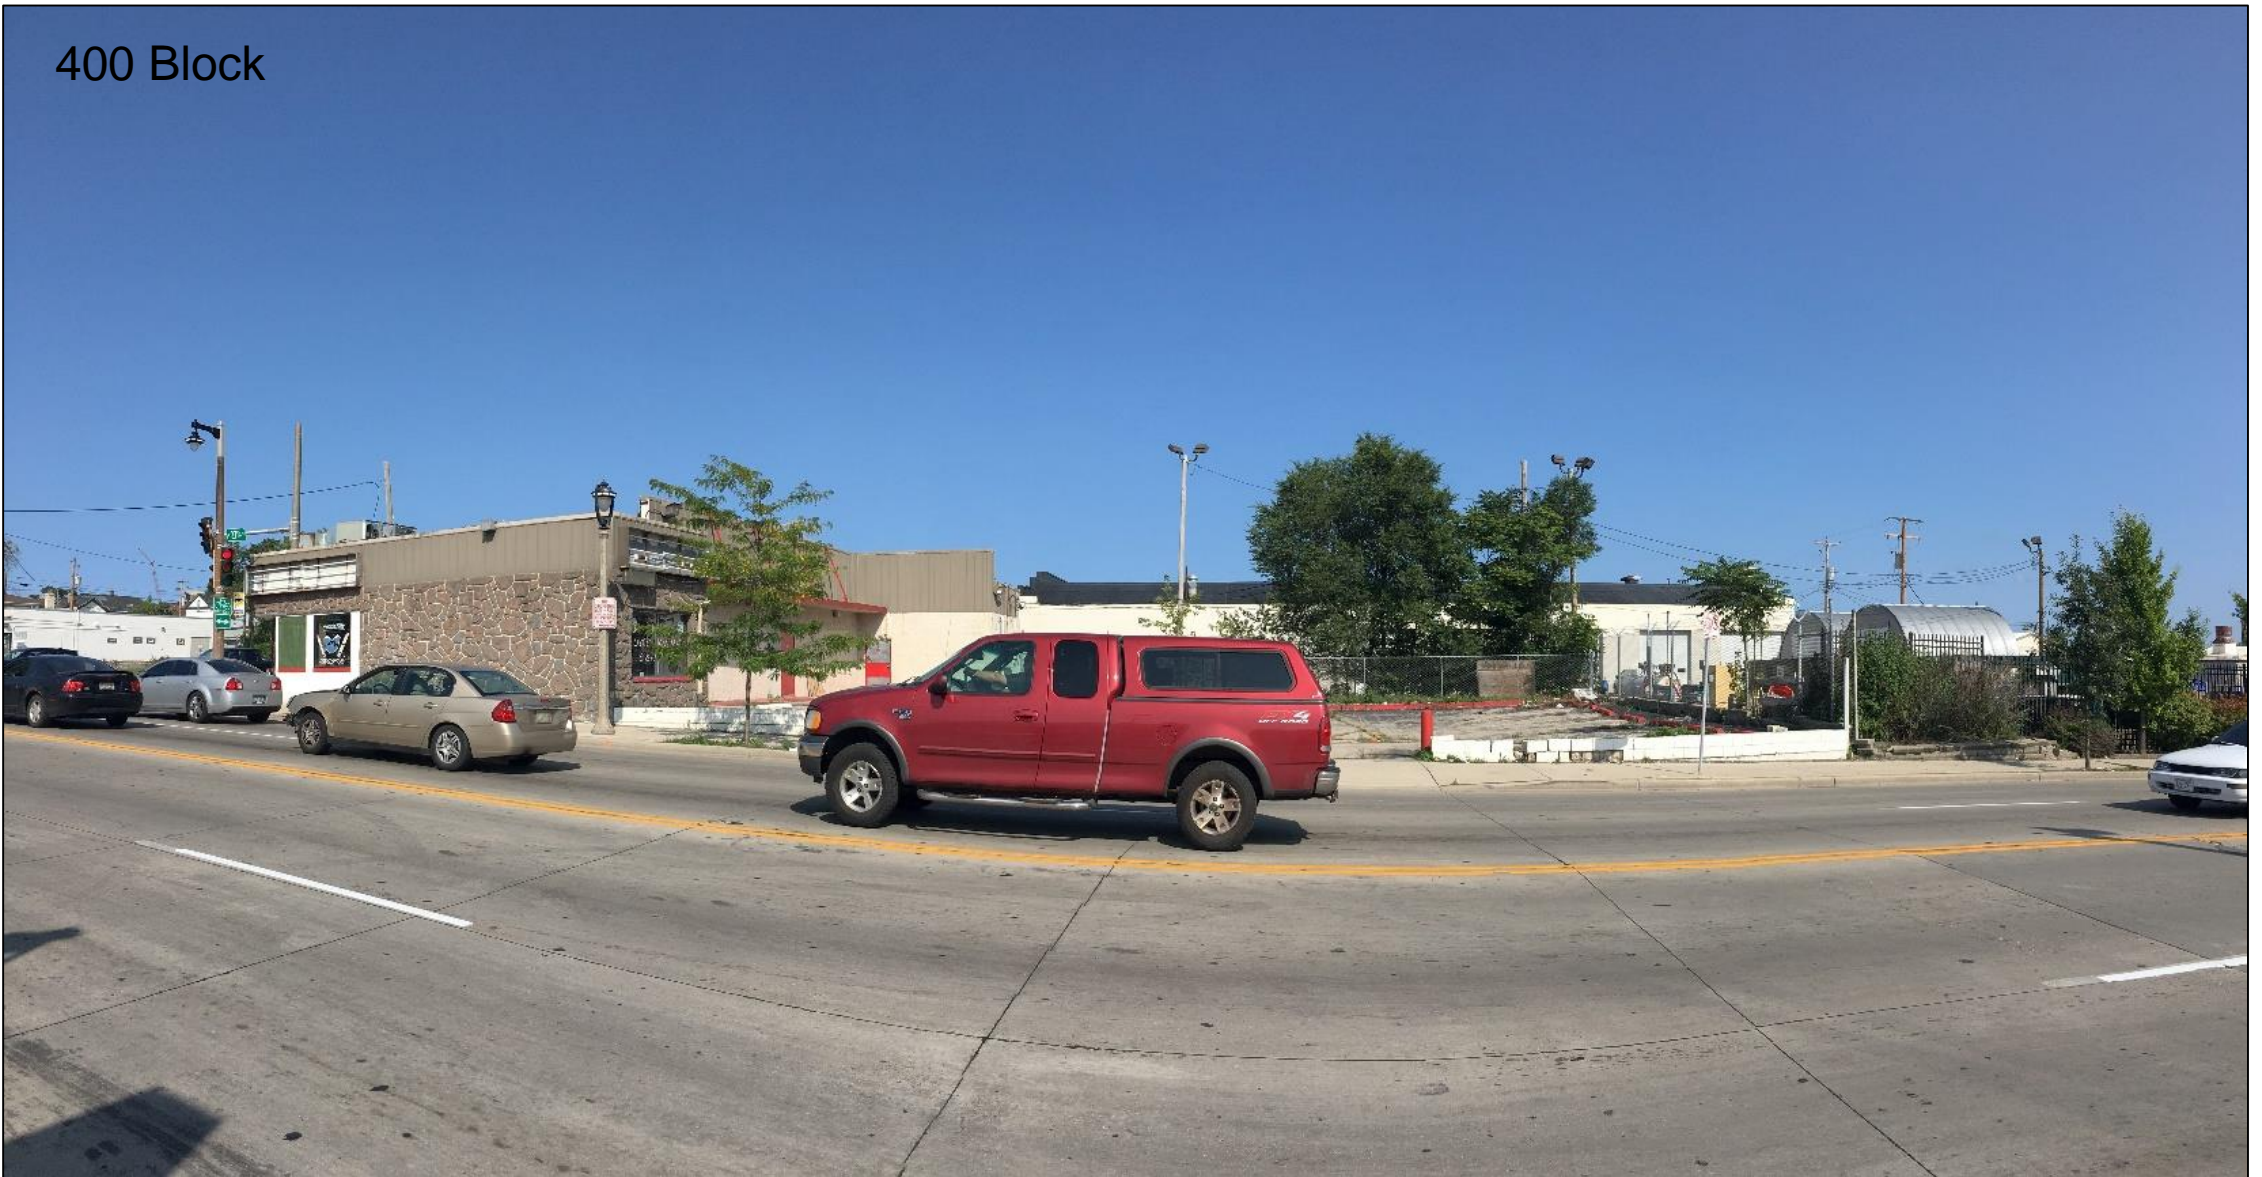
400 Block

- Parking lot is un-kept with piles of debris visible from the street. Together with the broken wall signs and boarded up windows, the property negatively contributes to the well-being of the corridor.

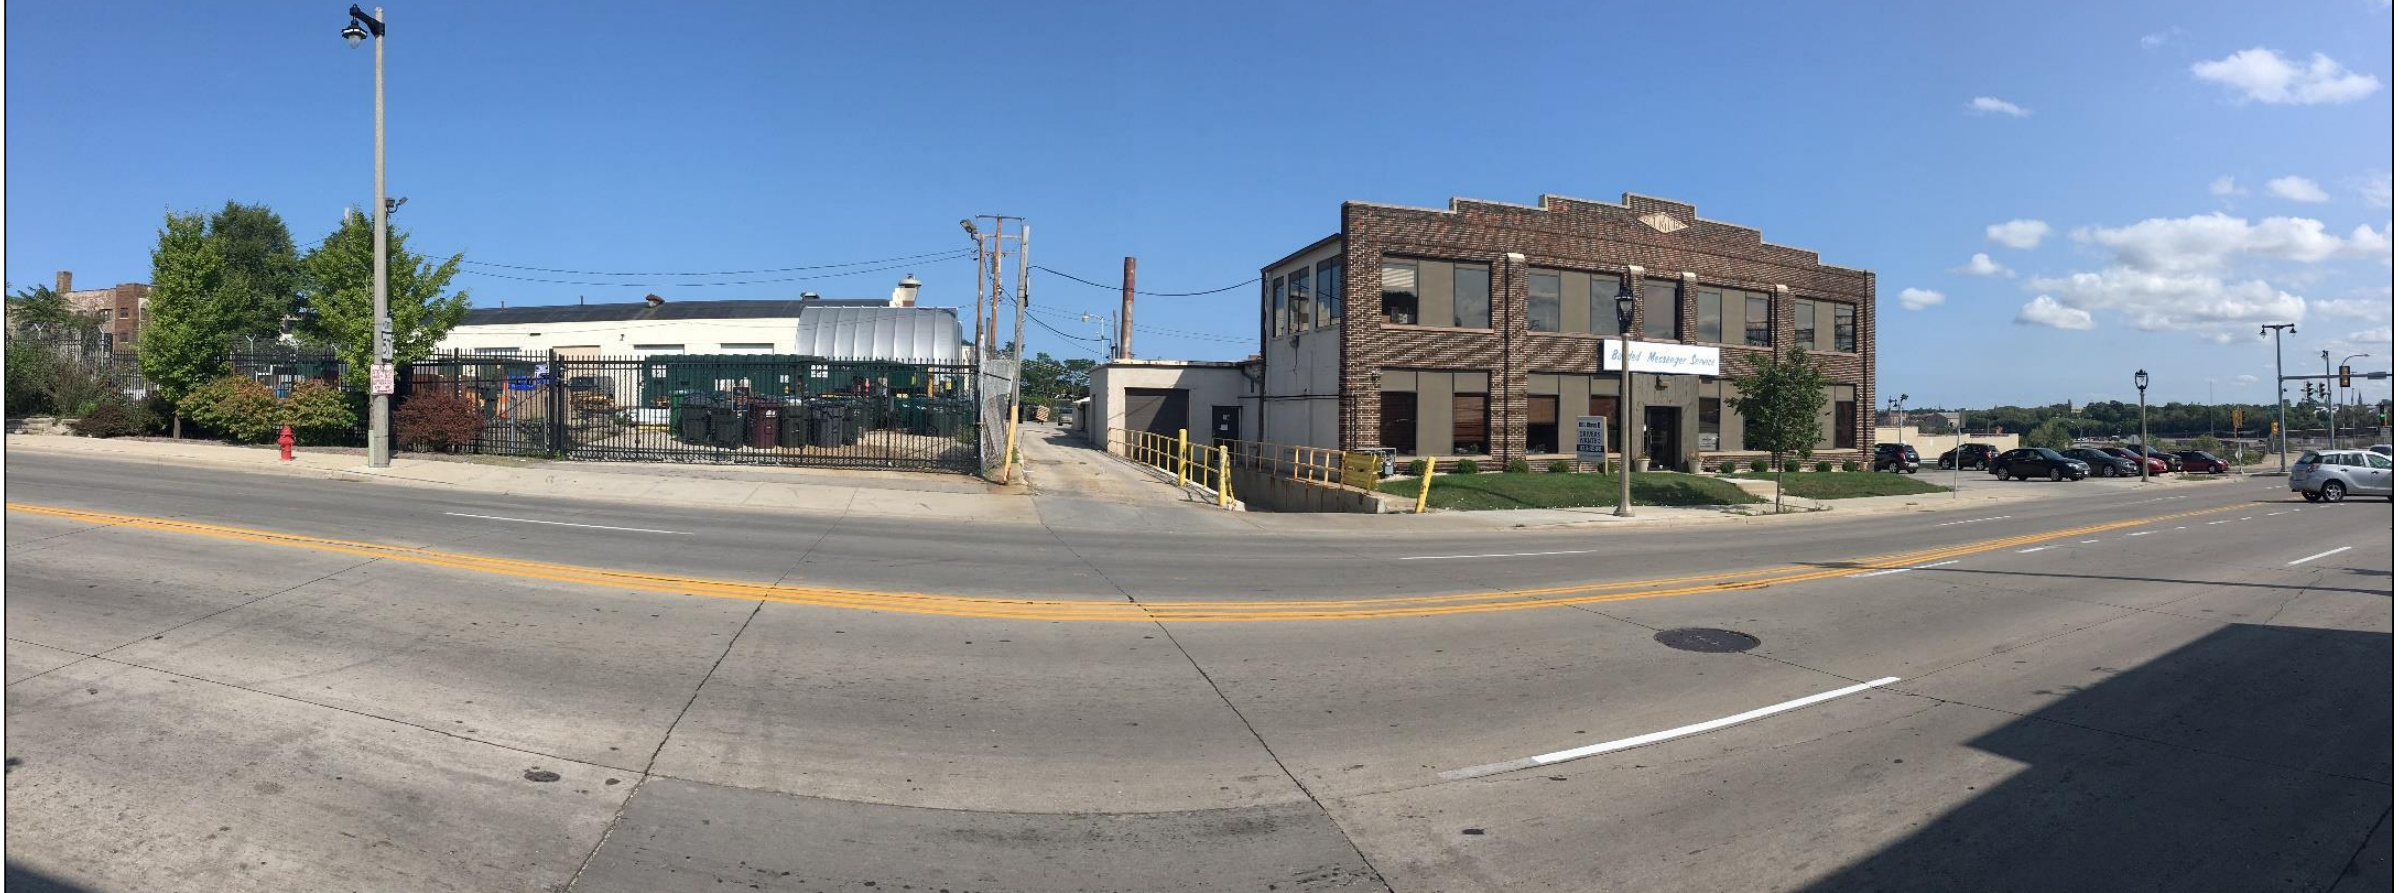
400 Block

- Mature trees and landscaping improves streetscape but tall shrubs and low tree canopy obscure parking lot creating limited sight lines.
- Well maintained building but perimeter parking lot landscaping would improve condition at prominent St. Paul Avenue corner.

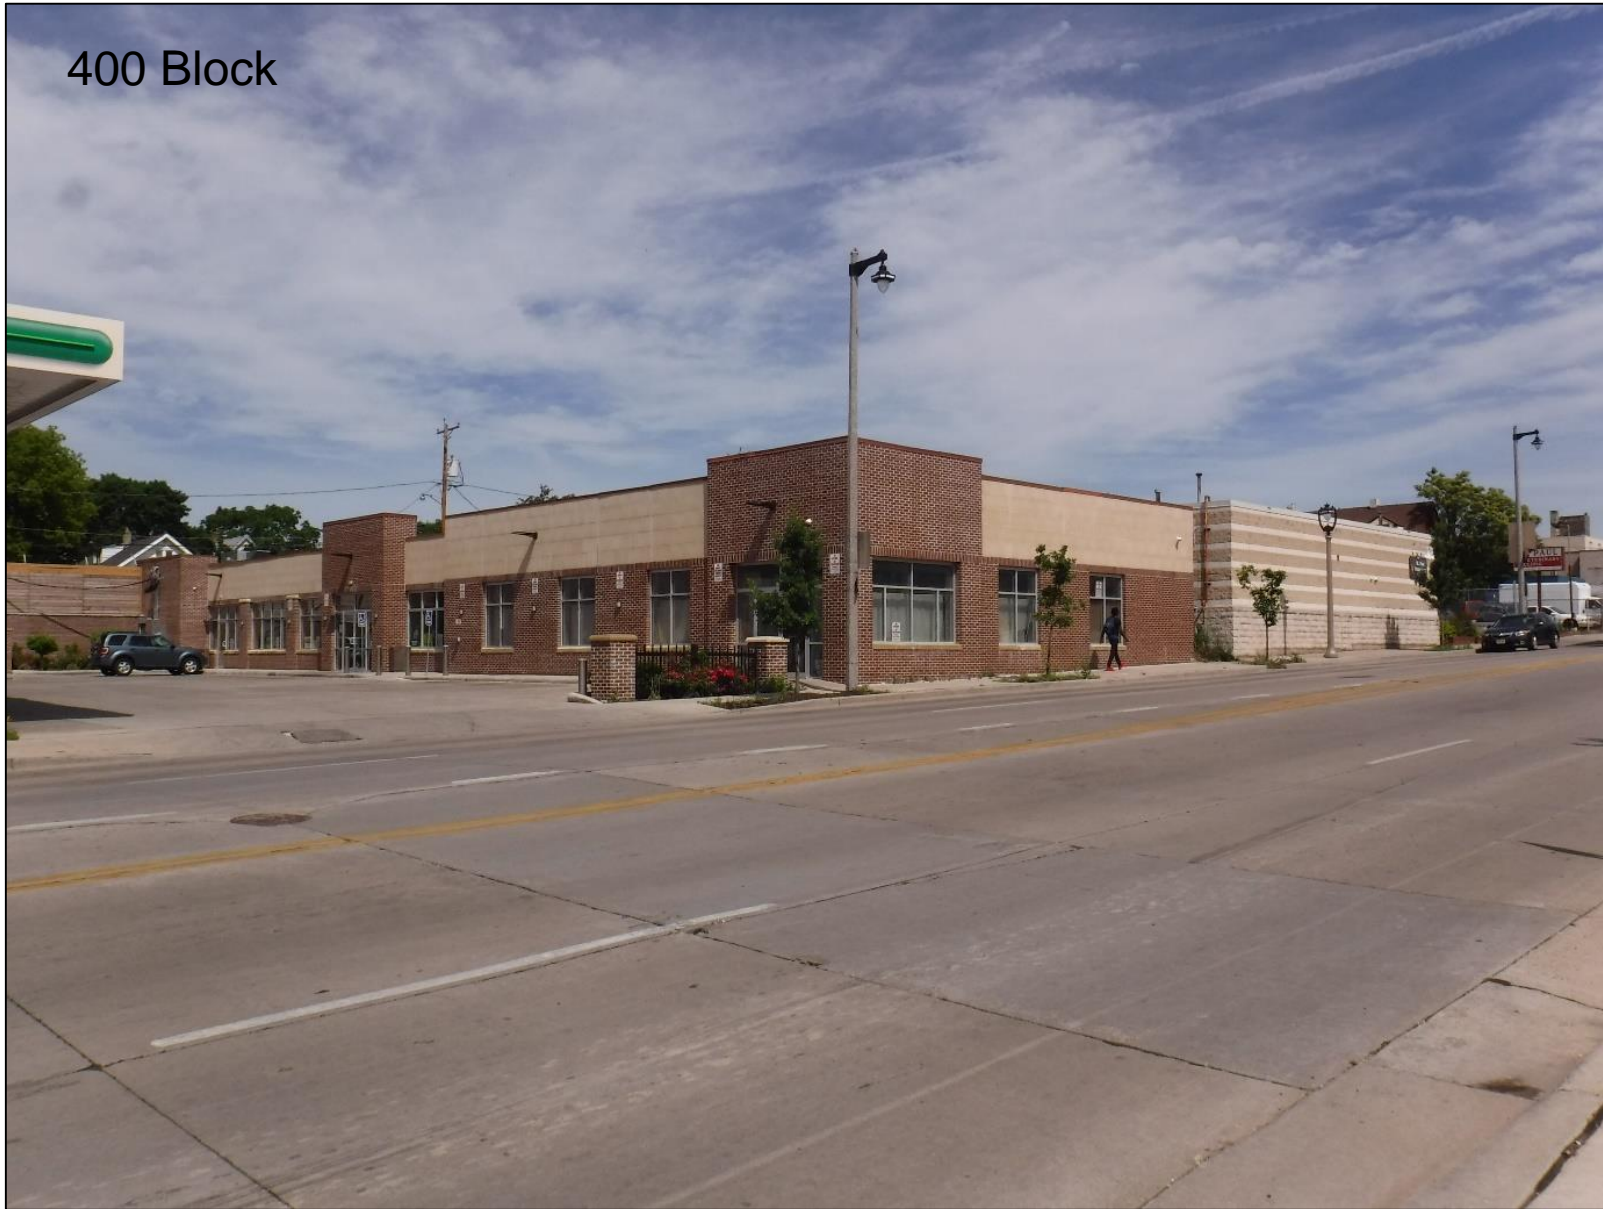
400 Block

- Newer development with ample and clear glazing with attractive parking edge landscaping. Property is open with little to no obstructed site lines.

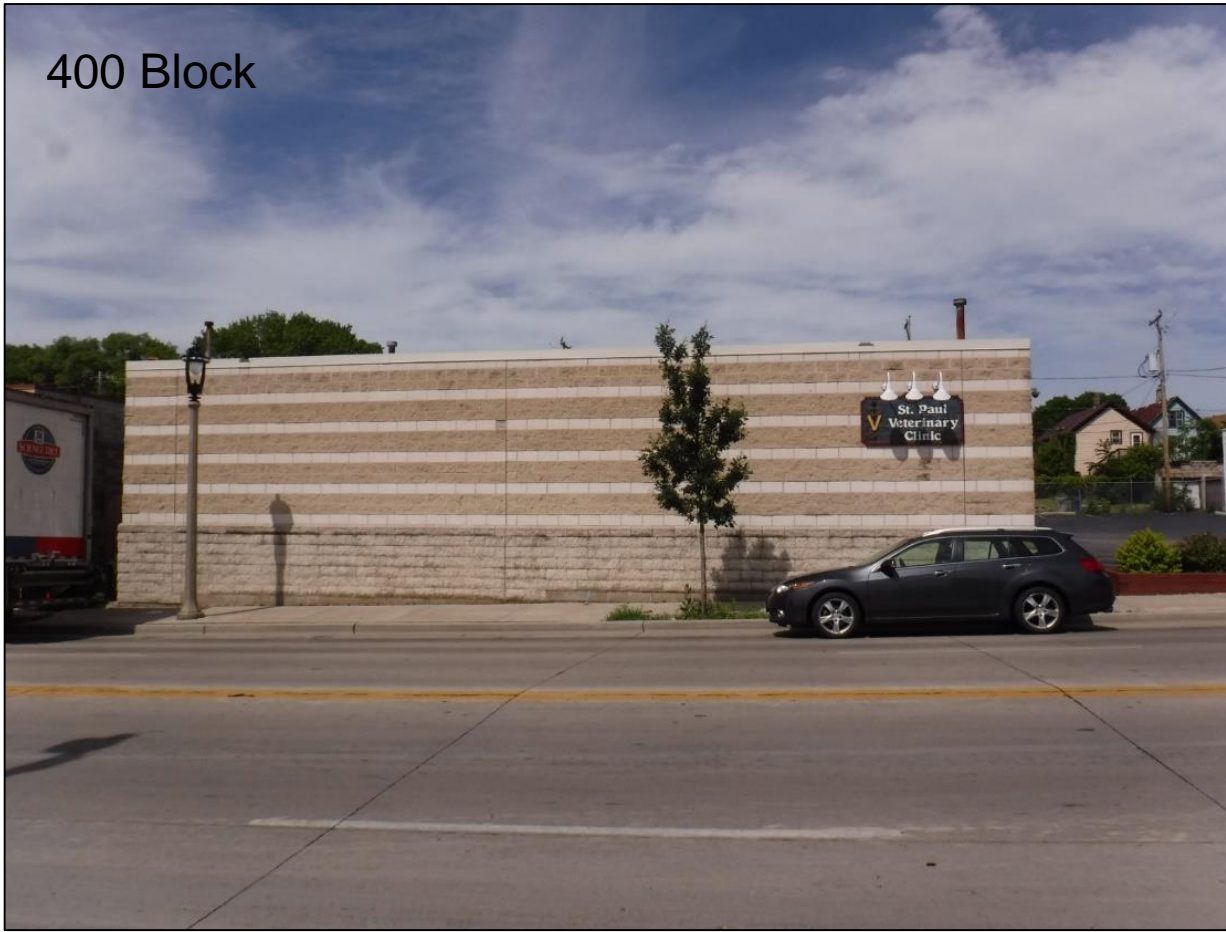
400 Block

- Suggested considerations to North 27th building face include landscaping, lighting, or increased fenestration if feasible.

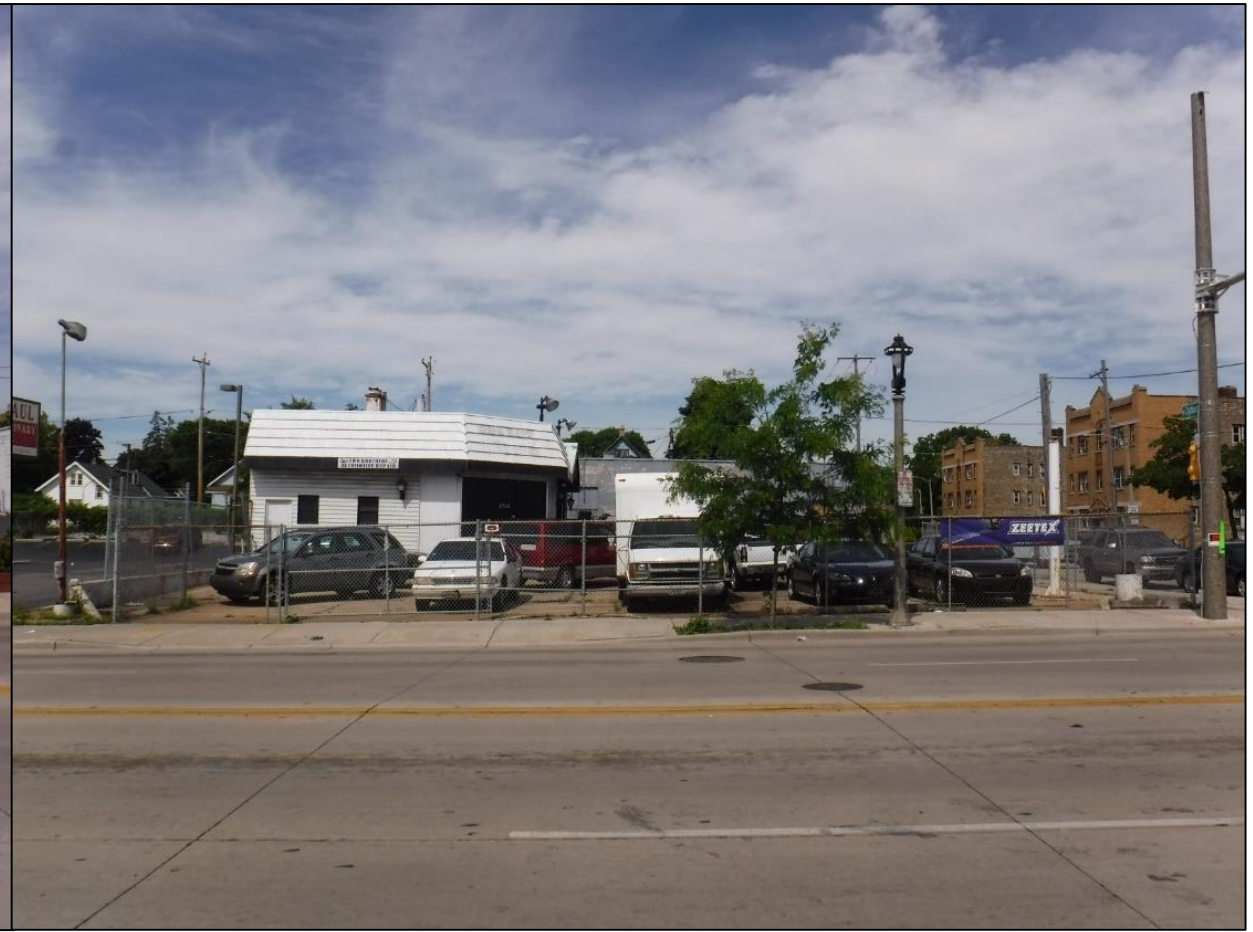
- Chain link fence abutting sidewalk detracts from public realm and street image and makes for an uninviting street corner.

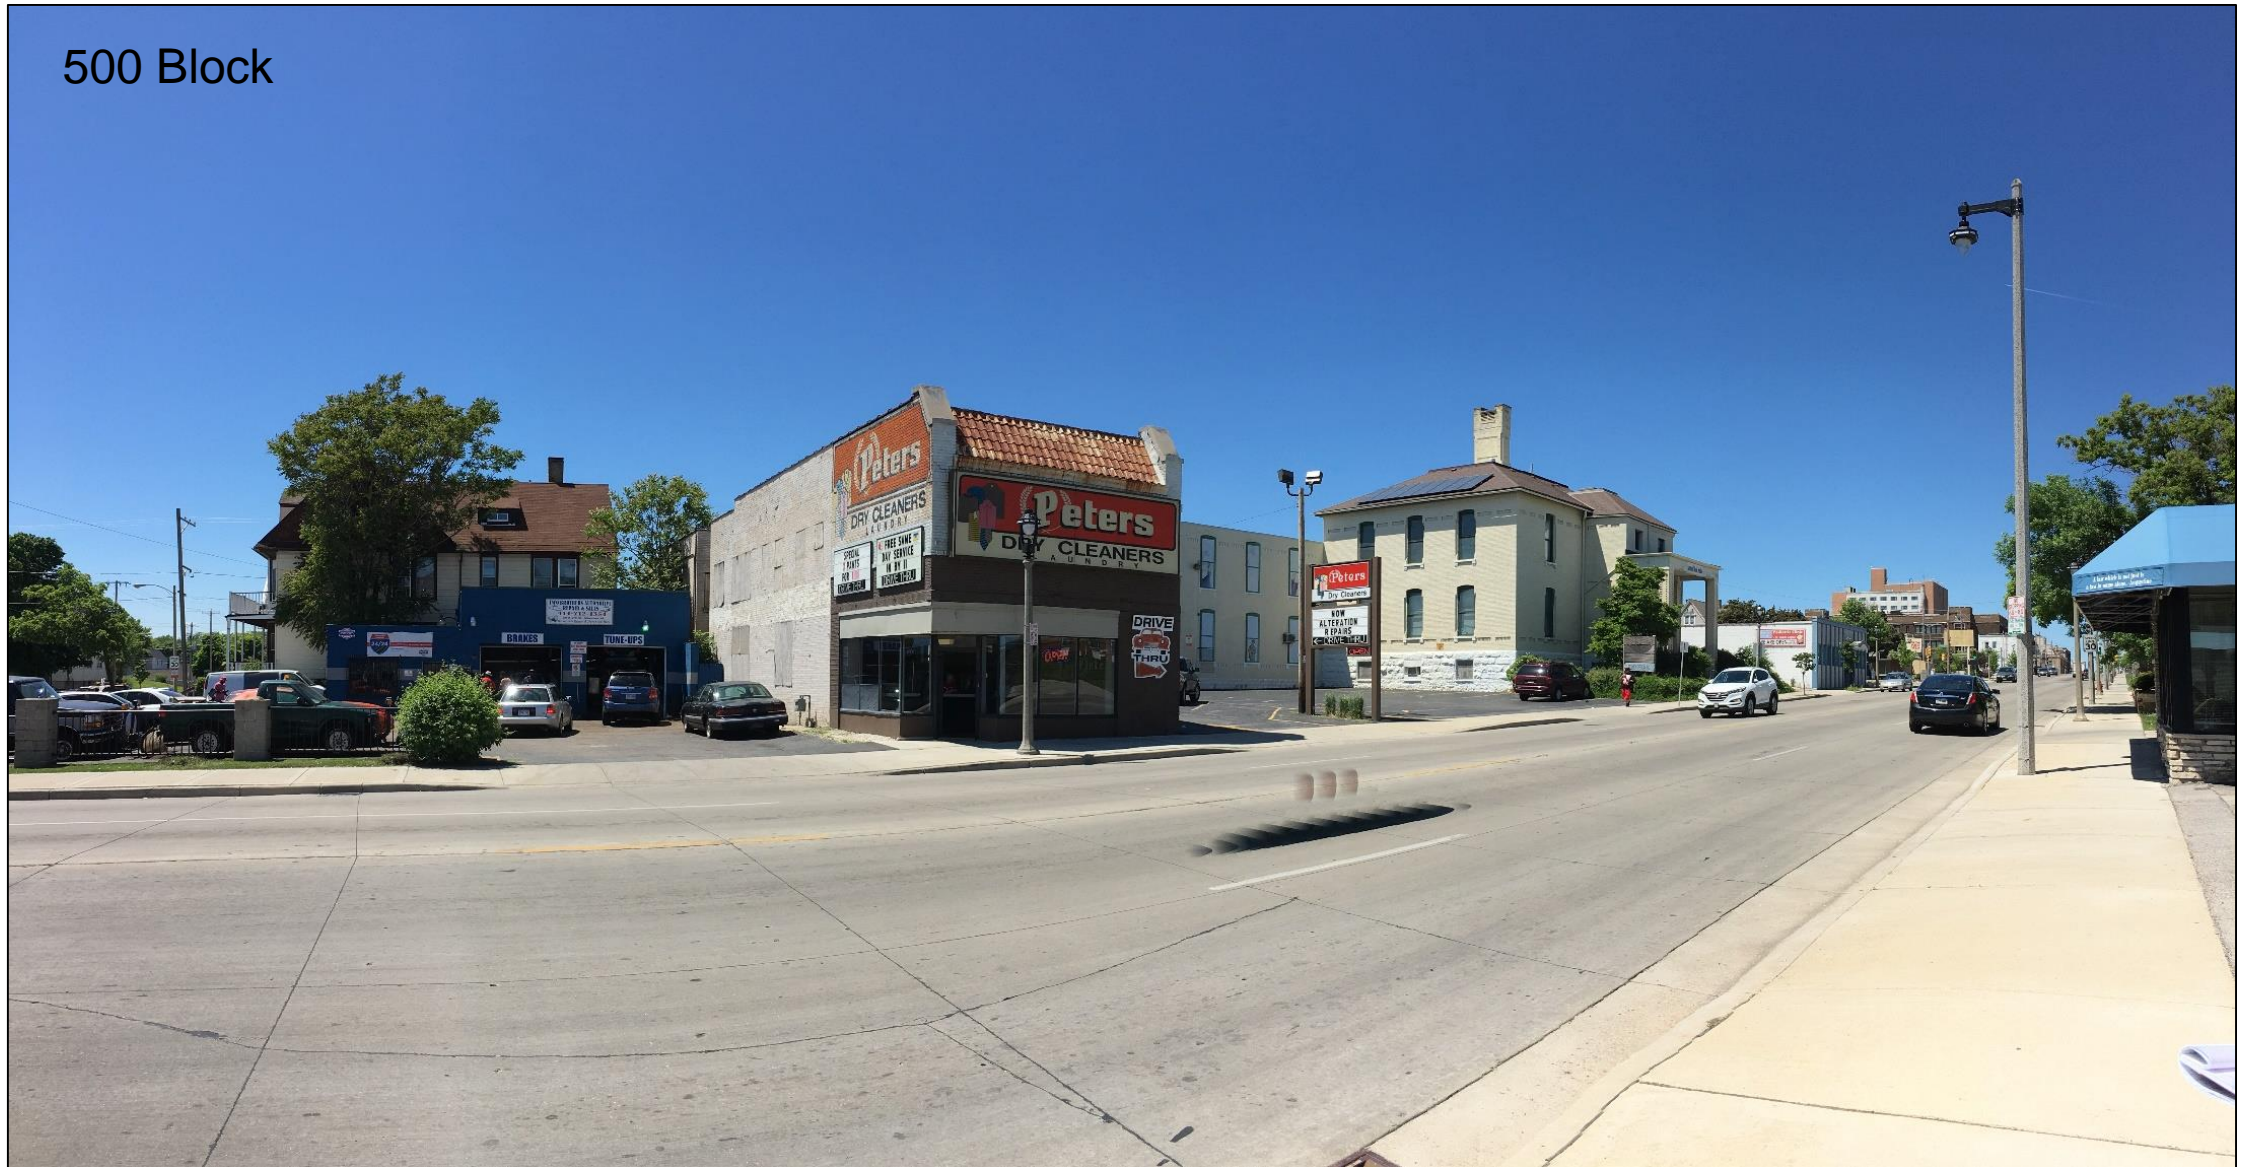
500 Block

- Canopy tree in adjacent lot may diffuse full lighting coverage; trimming is recommended to improve site security.
- The large shrub at the entrance of the lot should be trimmed to create improved site lines.

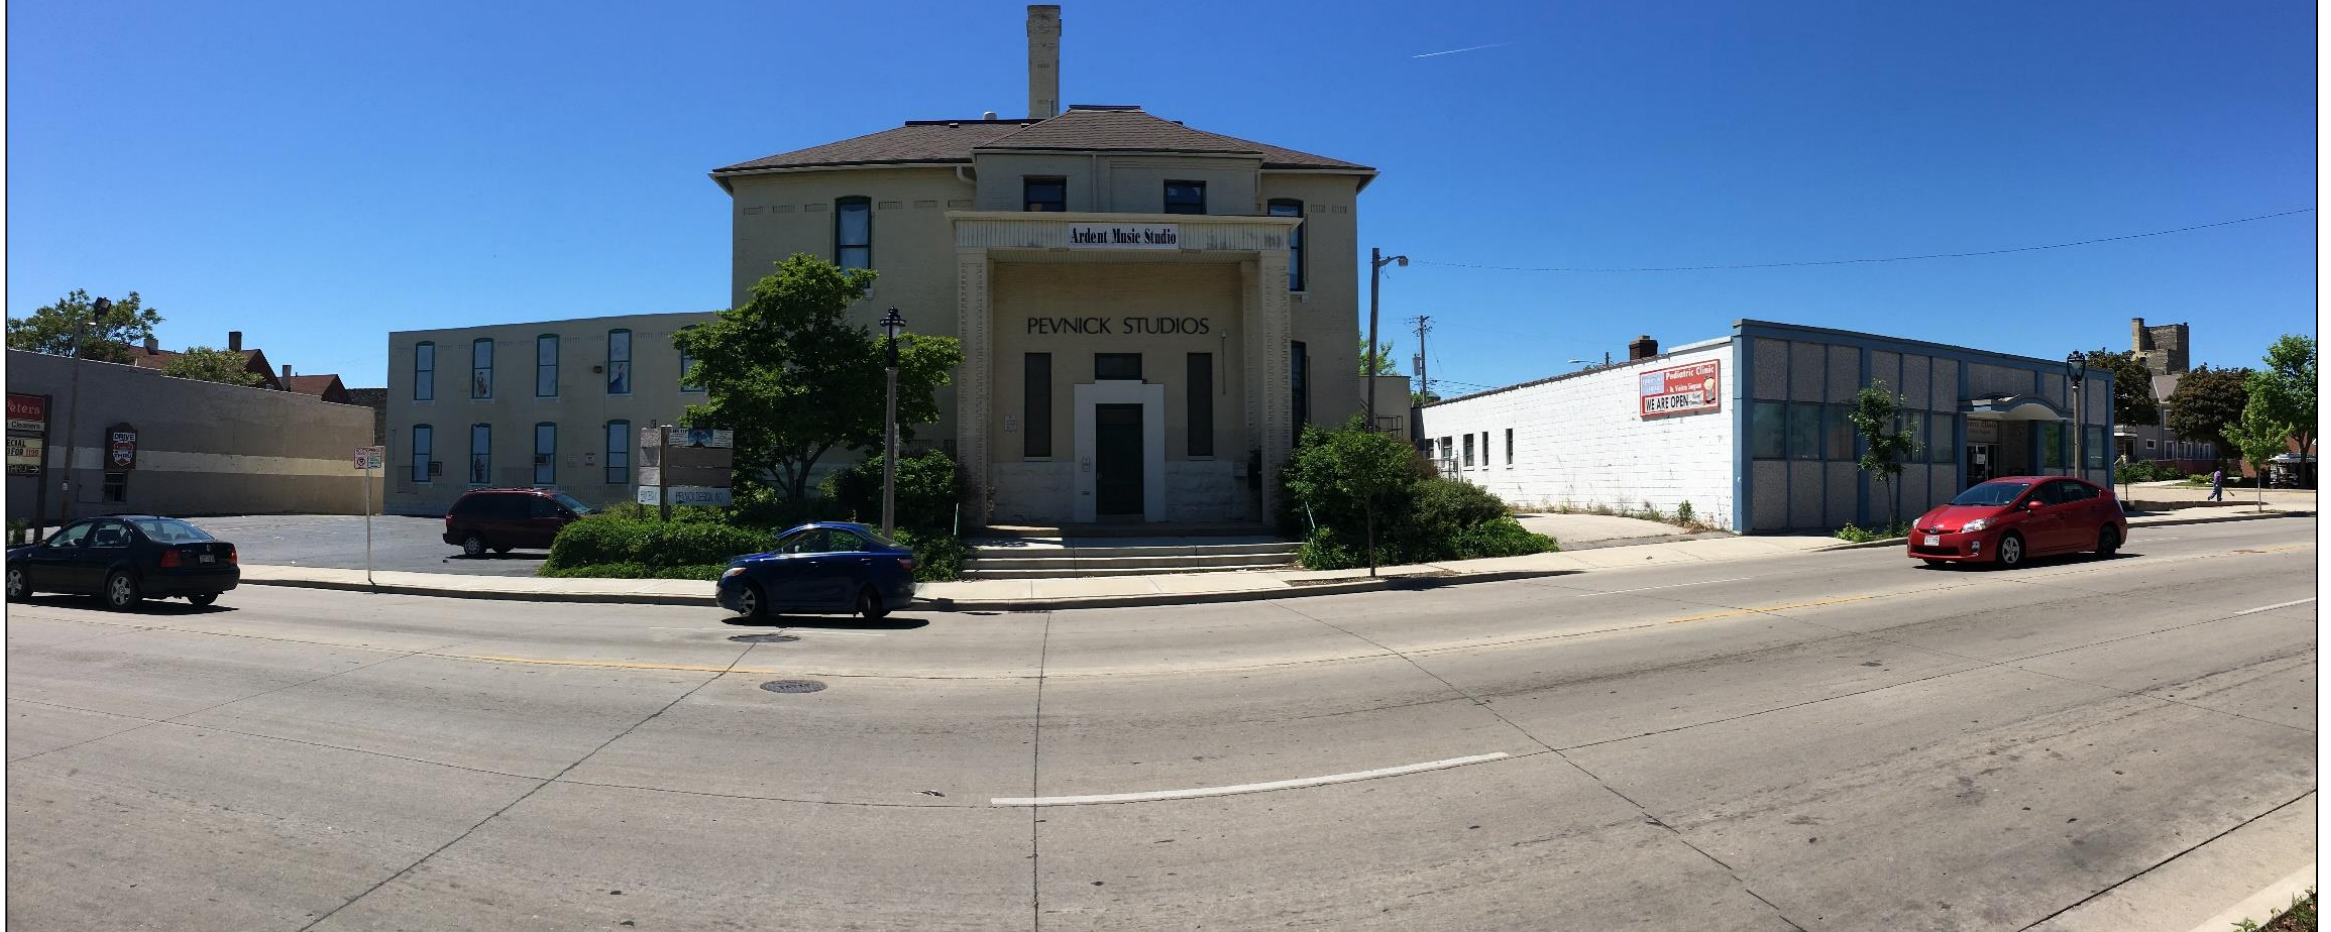
500 Block

- Overgrowth of landscaping creates security issues with blind spots and diminished sight lines.
- Creative mural enlivens and improves the parking lot area of the property.

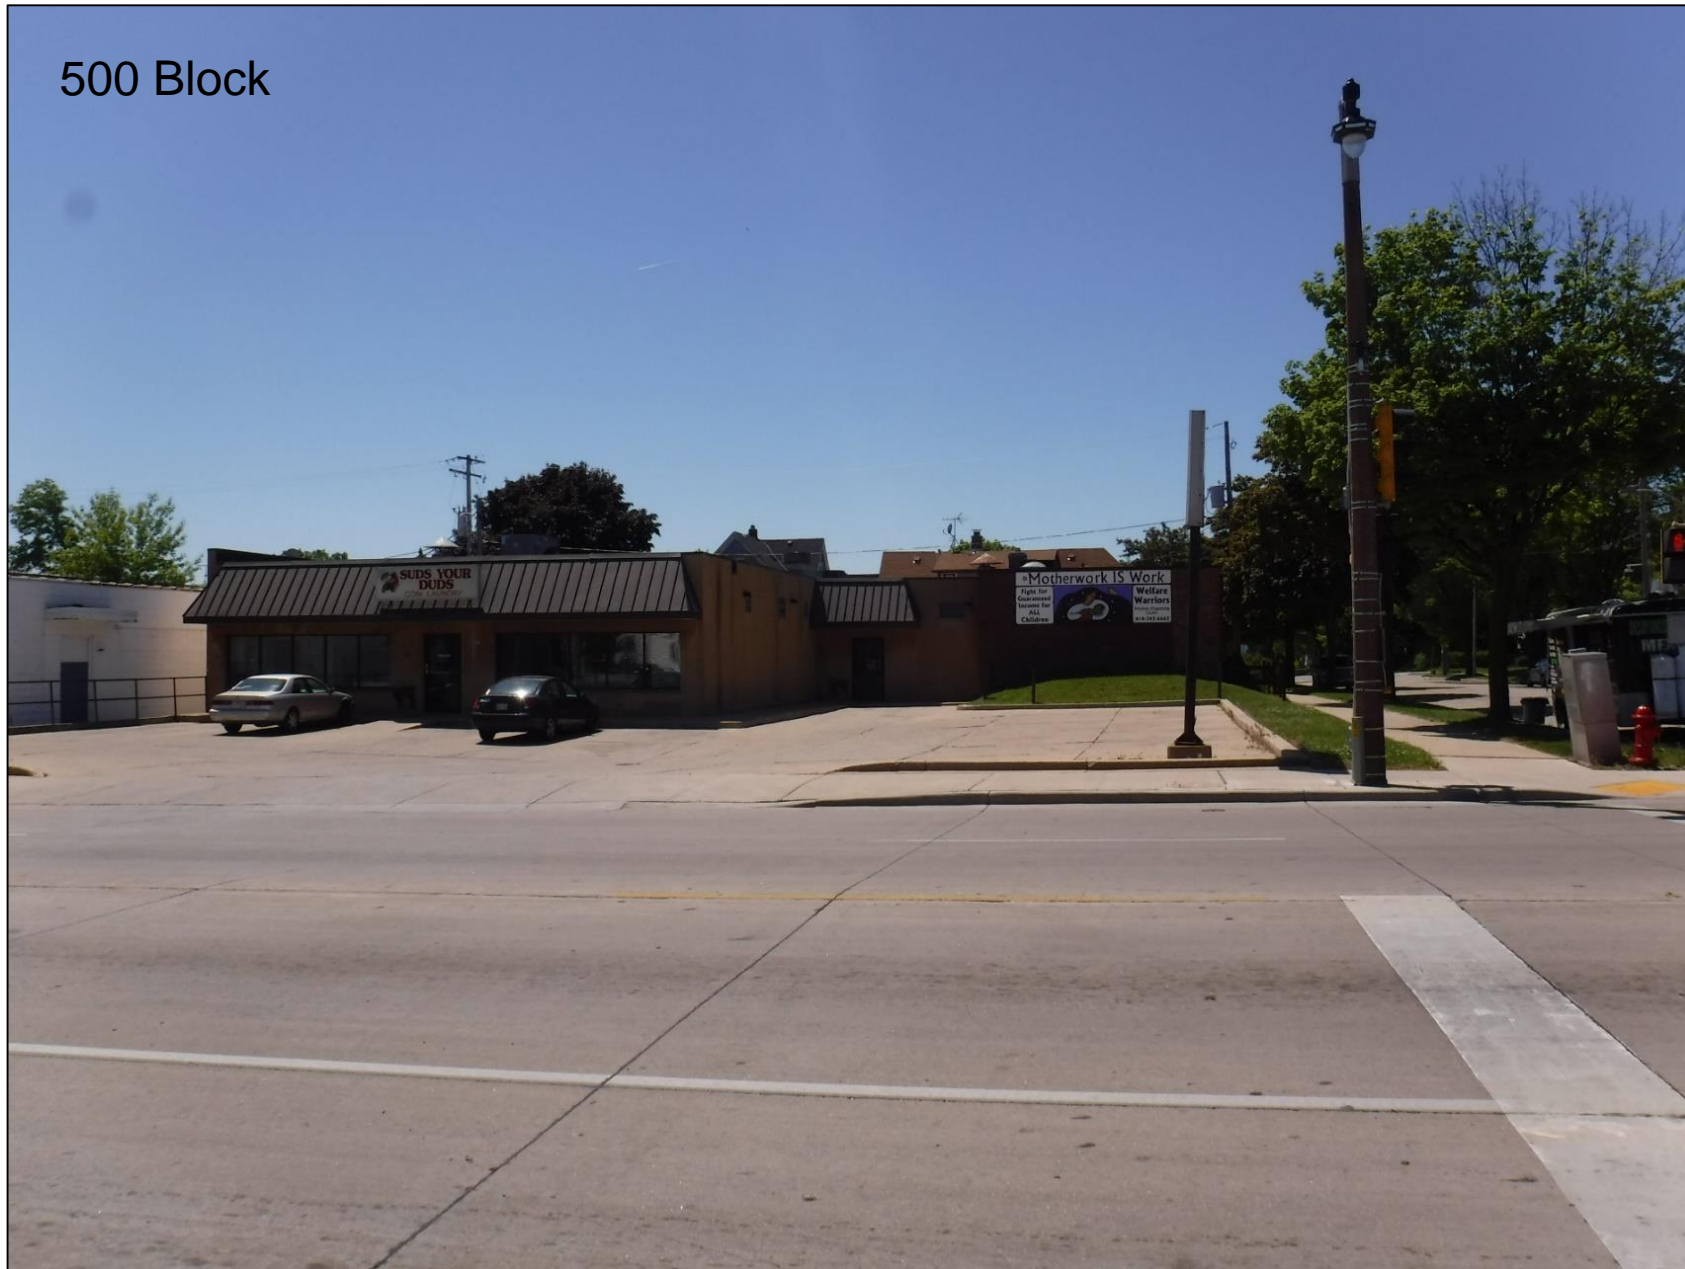
500 Block

- Add landscaping to perimeter of surface parking lot to improve wide concrete expanse and improve pedestrian realm.
